# XBLOC INNOVATIONS AT SWINOJSCIE BREAKWATER

Richard de Rover<sup>1</sup>, Bas Reedijk<sup>1</sup> and Pieter Bakker<sup>1</sup>

For the new breakwater in Swinoujscie, Poland, Xbloc has been used as breakwater armour layer. The local conditions in this region with low temperatures in the winter season and poor under water visibility required some innovative solutions to design and build this impressive marine structure. The project was the first Xbloc application where sea ice is expected. An assessment was therefore made of the expected ice loads and possible damage mechanisms due to these ice loads. It was concluded that the chance of damage to the armour layer as a whole was minimal, but an increased concrete strength was applied to deal with the ice forces on individual units. The concrete mix and the production process were adjusted as a result of the low winter temperatures. Furthermore the echoscope<sup>®</sup> realtime sonar was used to guide the underwater placement in poor visibility conditions. In this paper design and construction aspects are presented of the Swinoujscie breakwater.

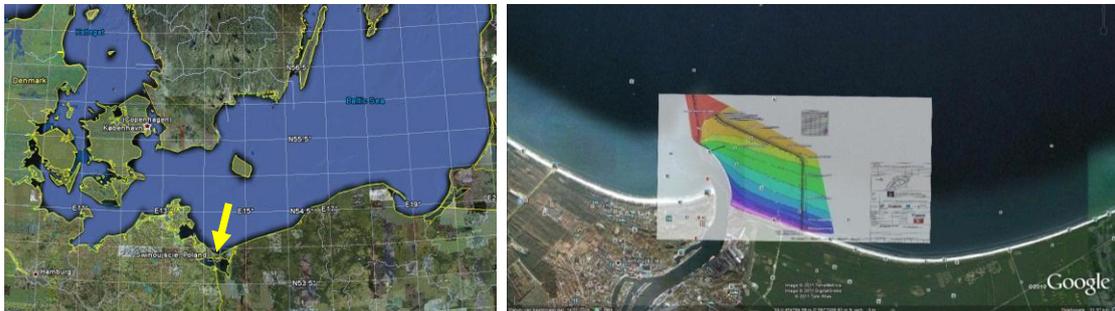
Figure 1. Project location and layout of new Swinoujscie breakwater.

The port of Swinoujscie is located on the Polish Baltic Sea coast, close to the border with Germany. On the east side of the existing breakwater an LNG import terminal is developed for which a new 3 kilometer long breakwater was built, creating the new Swinoujscie External Port.

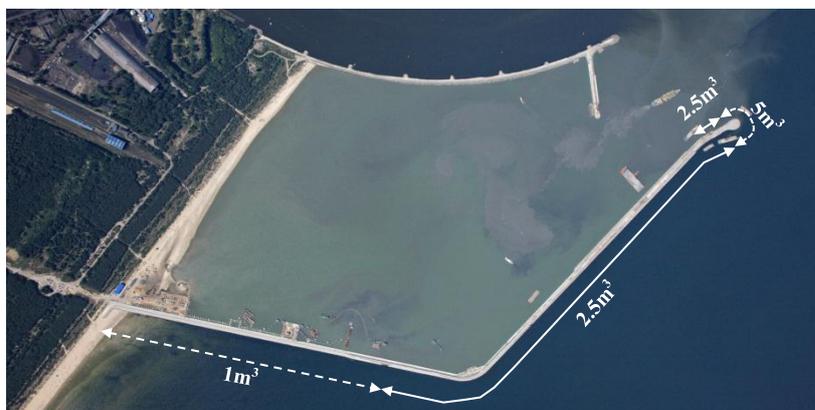
Although breakwaters in Poland are traditionally armoured with tetrapodes, Xbloc armour units were applied for this project in order to reduce the required concrete quantity. The block sizes used were  $1\text{m}^3$ ,  $2.5\text{m}^3$  and  $5\text{m}^3$  as can be seen in Figure 2. The stability of the  $1\text{m}^3$  and  $2.5\text{m}^3$  blocks was confirmed by 2D physical model tests in DMC's wave flume. For the  $5\text{m}^3$  blocks, no physical model tests were carried out, given the conservative block size that was chosen and the tight project schedule.

Figure 2. Overview of Xbloc sizes along breakwater alignment

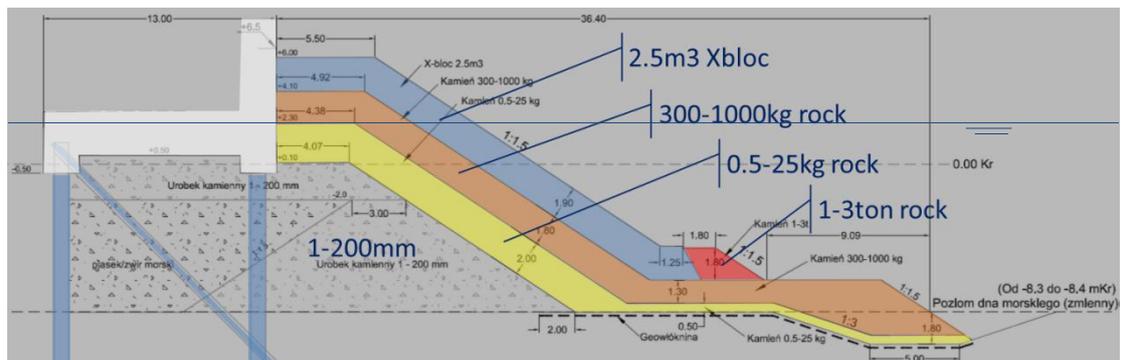
The main cross section (Figure 3) consists of a quay wall at the port side of the breakwater and a rubble mound breakwater slope on the sea side. The design wave height for the structure is  $H_s=4\text{m}$ , and initially a  $1.5\text{m}^3$  Xbloc armour was chosen for the main section of the breakwater. However during the physical model tests at high water levels ( $KR + 2.2\text{m}$ ) the armour layer stability did not meet the design requirements as a result of the low relative freeboard in combination with the large impermeable crown wall. As a result of these tests, an Xbloc size of  $2.5\text{m}^3$  was chosen. The under layer consists of 300-1000kg rock and a secondary under layer of 0.5-25kg rock is applied to separate the 300-1000kg under layer from the fine core material. At the breakwater toe, a rock apron is partly buried into a dredged trench in order to accommodate possible seabed erosion. A geotextile is applied underneath the breakwater toe in combination with a layer of 0.5-25kg rock.

Figure 3. Main breakwater cross section

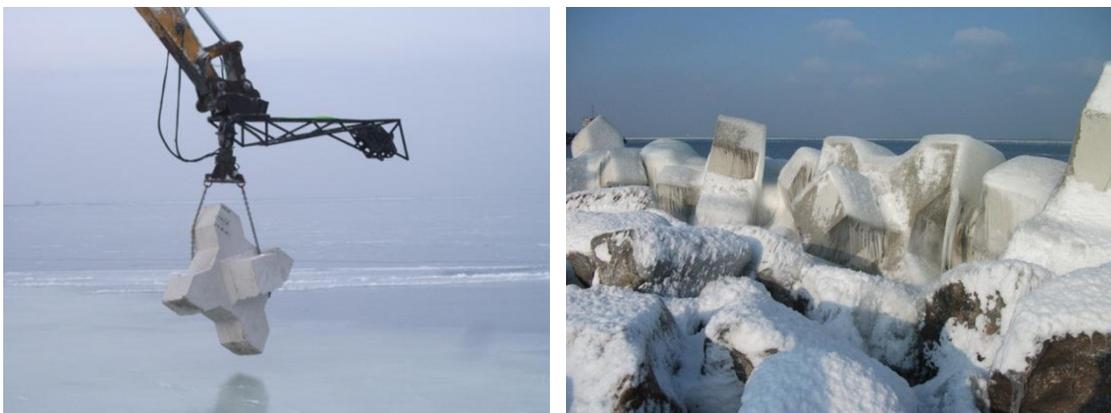
Figure 4. Impression of winter conditions during the construction period of the breakwater

Due to the low winter temperatures in the Swinoujscie area, sea ice can occur at project location (Figure 4). An assessment was made in consultancy with Witteveen+Bos of possible damage mechanisms as a result of sea ice (see Figure 5). The damage mechanisms that were assessed are:

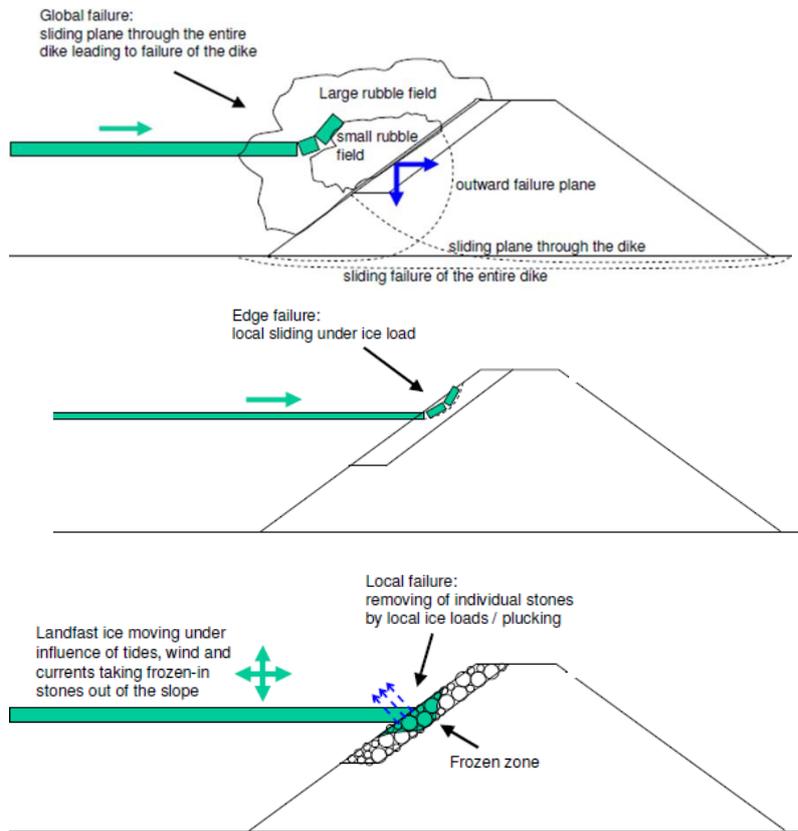
1. Global failure: the ice moves the whole breakwater from its position.
2. Edge failure: the ice moves a part of the armour layer.
3. Local failure: units which are frozen into the ice sheet are removed from the armour layer due to movement of the ice sheet.

Figure 5. Damage mechanisms due to ice load: A) Global failure (top); B) Edge failure (middle); C) Local failure (bottom)

It was concluded that the chance of these types of damage occurring at the Swinoujscie breakwater is very low given the limited thickness and crushing strength of the ice in this area of the Baltic Sea and due to the fact that there is no significant tidal water level variation.

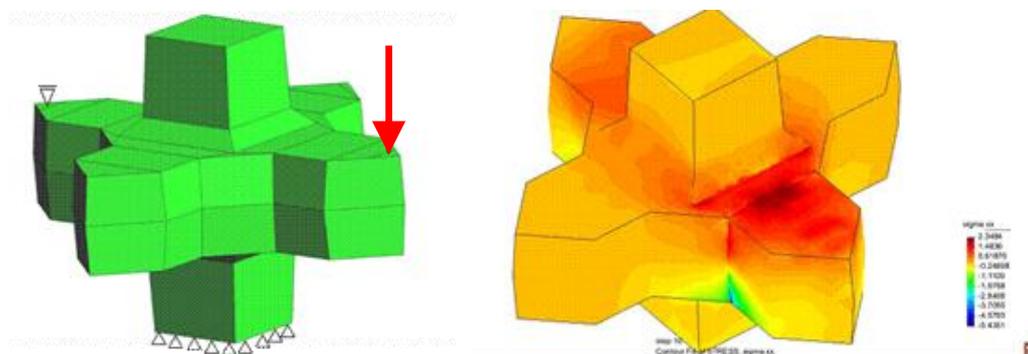
Apart from the analysis described above, FEM calculations were performed in order to determine the concrete tensile strength required to withstand the force of the ice sheet pushing with its maximum crushing strength on one leg of an Xbloc which is conservatively assumed to be fixated fully by interlocking with the surrounding blocks. On the basis of these calculations, the concrete tensile strength was increased from 2.5MPa to 3.8MPa.

Figure 6. FEM Calculations to determine required concrete strength to withstand ice force on a unit

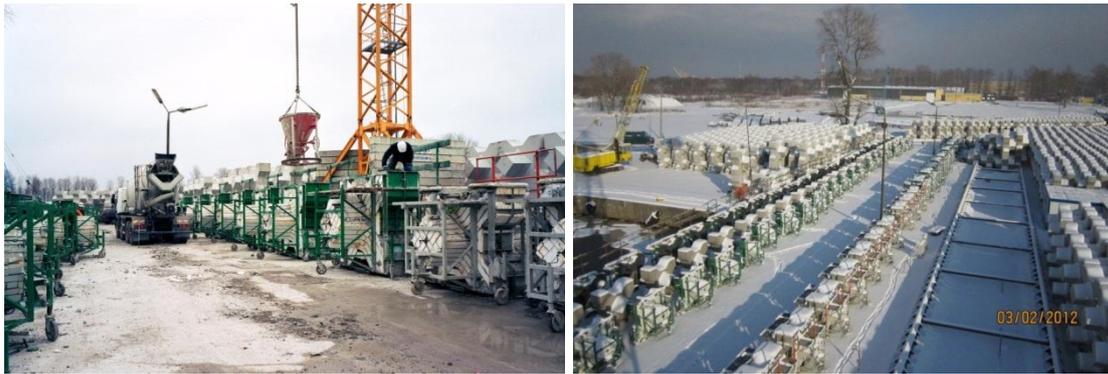
Given the tight schedule of the project, Xbloc production continued during the winter months when the temperatures dropped below 0°C. The concrete mix design was adjusted by pre-heating the mixing water and the aggregates. The moulds were insulated with polystyrene (Figure 7) and the blocks were de-moulded after 2 or sometimes 3 days instead of after 1 day in order to obtain sufficient concrete strength and an acceptable temperature gradient between the fresh concrete surface and the ambient temperature.

Figure 7. Xbloc moulds with polystyrene insulation for winter production

Because of the cold winter conditions during the block production, Xblocs were produced with an adjusted mix design, insulated moulds and an increased curing time.

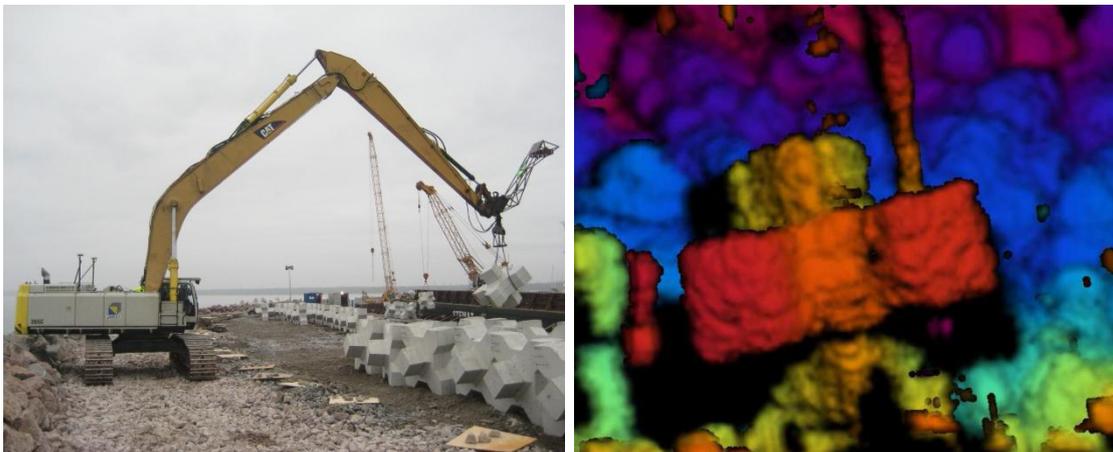
The echoscope is a high definition sonar device which, in combination with fast processing software, provides the crane operator a real time image of the block which is being placed, the surrounding blocks and the under layer. The sonar is attached to the boom via a frame (Figure 8) and transmits images to the operator as soon as the sonar is submerged.

Figure 8. Excavator with Echoscope frame attached to the boom (left); example of Echoscope image (right)

The experiences with the echoscope during the Swinoujscie project were very positive. The sonar enabled the crane operators to manoeuvre the Xblocs in a good interlocking position and to see the chain during the releasing of the block. This was especially useful during the placement of the units in the first 2 rows as it reduced the number of blocks that rolled away due to the chain getting stuck during the releasing of the block. The placement rates that were achieved in the Swinoujscie project were in the order of 2-8 blocks per hour for the blocks in the 1<sup>st</sup> and 2<sup>nd</sup> row and in the order of 12-16 blocks per hour for the blocks in the remaining rows.

The echoscope basically functions as a camera in water where a normal video camera would not work due to the poor visibility. An important advantage of an acoustic system like the echoscope, compared to systems which are based on recording the blocks motions and rotations with an attached sensor, is that the acoustic system gives a real image of the blocks around the unit which is being placed. Systems which are based on the motion and rotation recording provide an image that is based on a model which contains information about the position and orientation of the other blocks at the moment that the sensor was disconnected, but block movements after the removal of the sensor are not included in this model. Therefore there can be a significant difference between the image and the real situation.

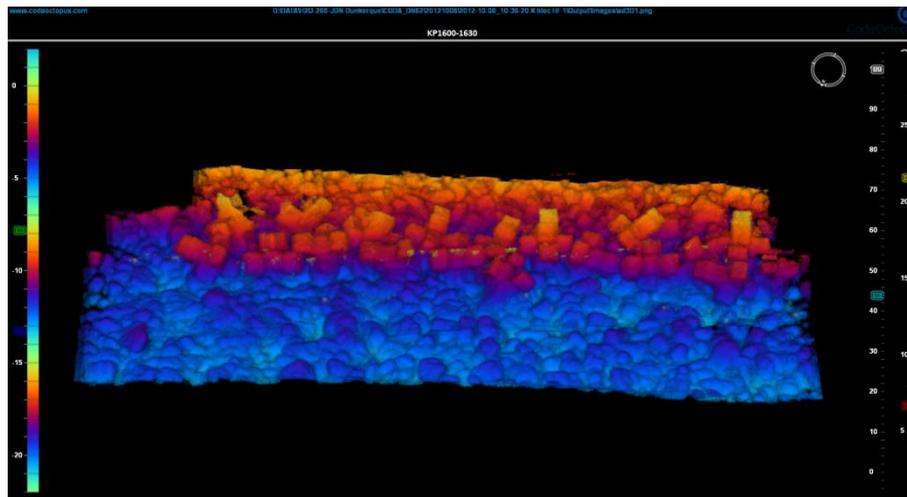
Figure 9. Example of echoscope survey after placement of the 2<sup>nd</sup> row of blocks.

It was found that the echoscope survey gives clear images to check the placement of the blocks after the placement of the 2<sup>nd</sup> row of units (Figure 9). The units are clearly distinguishable and it is possible to identify block that rolled into a cavity in the under layer rock bed. With regard to the survey after placement of the blocks up to the water line, it was found that close to the water line, the echoscope images show disturbance of reflections by the water surface. It was also found that the survey images were quite difficult to read (Figure 10). Due to the large number of blocks shown on an image it was difficult to identify the individual blocks in such detail that the interlocking between all the blocks could be checked. The survey results were therefore used to identify large voids in the armour layer and locations where a block protrudes out of the armour layer. Divers then inspected these areas in the armour layer to see if a rectification was required or if the interlocking between the blocks was sufficient.

As a result of the poor visibility below the water surface, it was difficult to carry out a dive survey to inspect completed breakwater sections. With limited visibility, a diver can only see a part of an armour unit from a very close distance and as a consequence it is difficult to get an understanding of the orientation of an armour unit in relation to the surrounding blocks and to inspect the interlocking between the units. Therefore the surveys of the placed Xblocs were done with the echoscope. For these surveys, the echoscope was attached to a survey boat which sailed slowly along the breakwater. As the boat was equipped with DGPS, it was possible to store the echoscope measurements in a 3D model.

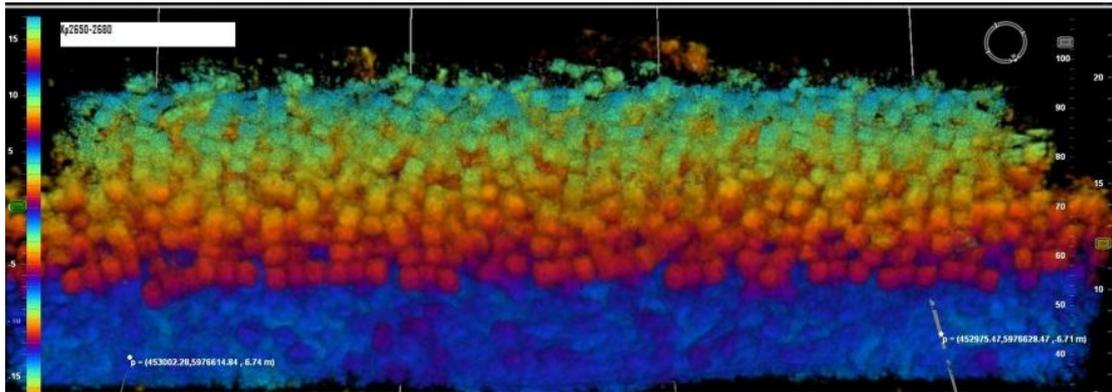
Figure 10. Example of echoscope survey after placement up to the water line.

Despite the fact that an echoscope survey does not allow for an inspection that is as detailed as a diver inspection in good visibility conditions, DMC considers the survey method to be one of the best possible options in poor visibility conditions such as in Swinoujscie.
